# What Roof Consultants Need To Know About Slate Roofs

By Joseph Jenkins

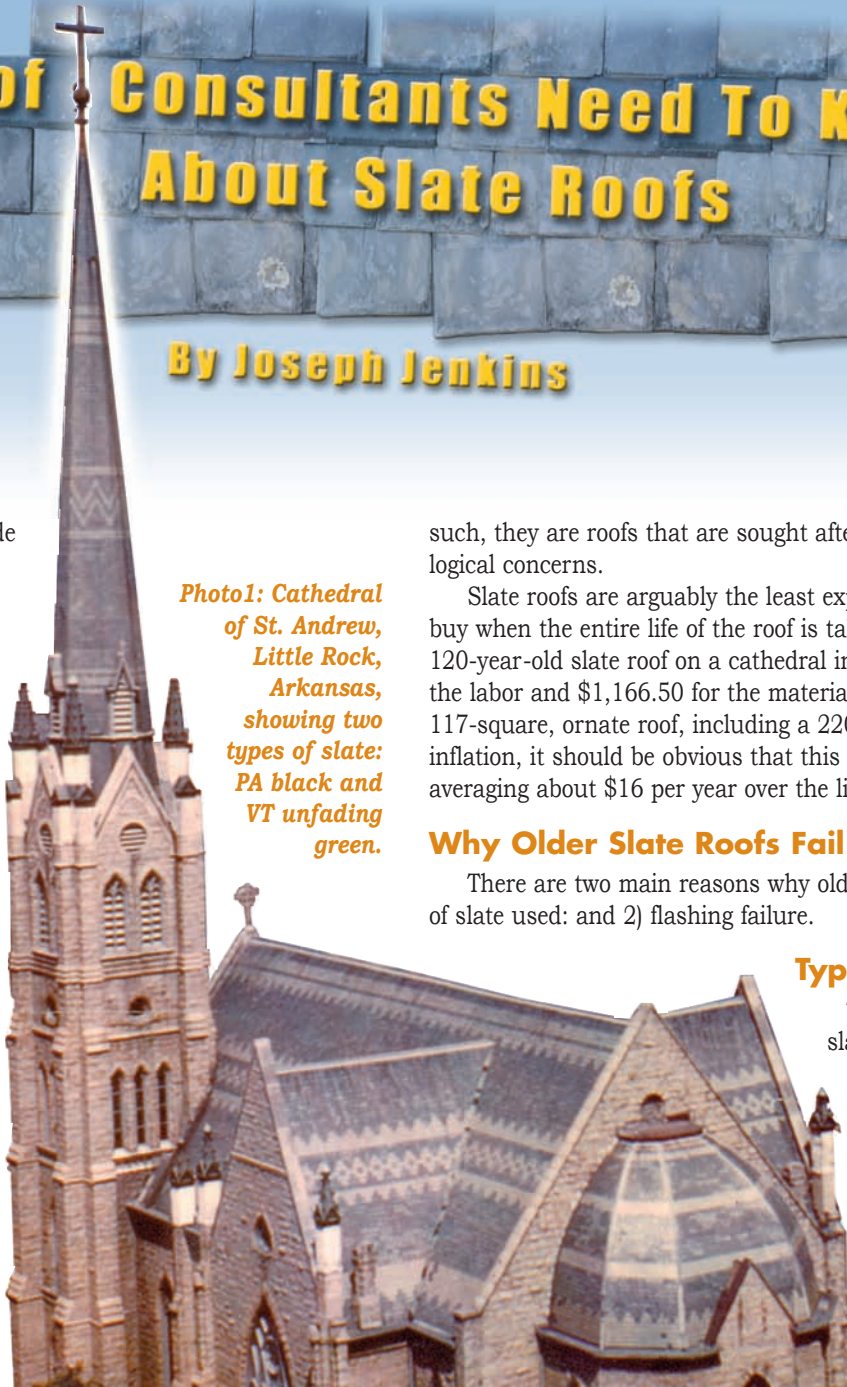
*Photo1: Cathedral of St. Andrew, Little Rock, Arkansas, showing two types of slate: PA black and VT unfading green.*

Slate roofs are arguably the least expensive roofs money can buy when the entire life of the roof is taken into consideration. A 120-year-old slate roof on a cathedral in Arkansas cost \$765 for the labor and \$1,166.50 for the materials in 1881 to install the 117-square, ornate roof, including a 220-foot spire. Adjusted for inflation, it should be obvious that this was money well spent, averaging about \$16 per year over the life of the roof (See Photo 1).

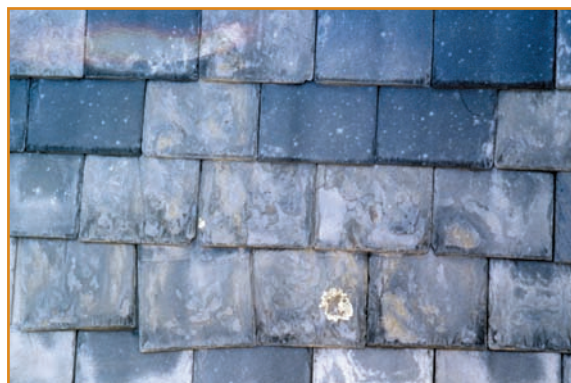
*Photo 2: Softer Pennsylvania black slate, 120 years old, on cathedral in Little Rock.*

black and green slate. The green slate originated in Vermont, while the black slate originated in Pennsylvania (Photo 2). The black slate had a life expectancy of about 120 years and was showing a lot of delamination and crumbling. The slates had served their useful life and were now failing. The green slates, on the other hand, showed no deterioration after 120 years (Photo 3). It's

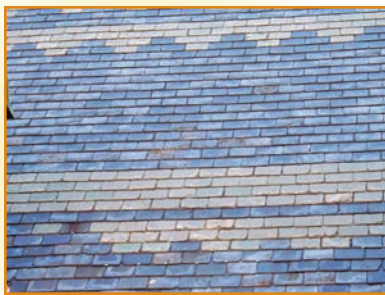
**Photo 3: Pennsylvania black and Vermont unfading green slate, 120 years old, on St. Andrews Cathedral. Black is worn out; green is still good.**

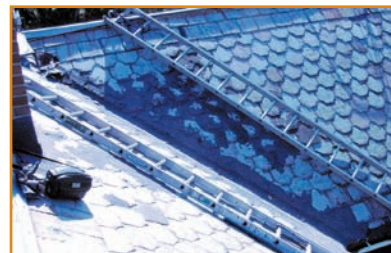
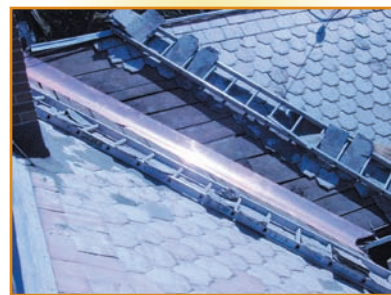
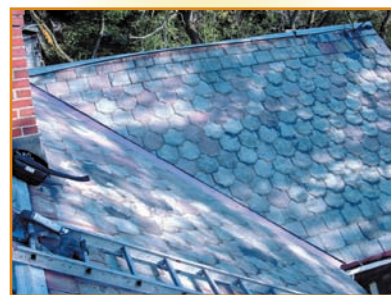
**Photos 4, 5, and 6: Typical flashing repair – before, during, and after: valley replacement on badly abused residential slate roof.**

When flashings begin to fail on a roof that is made of sound slates, only the flashings should be replaced, not the entire roof. This is routine work for slate roof restoration professionals (Photos 4, 5, and 6). One of the extraordinary characteristics of slate roofs is that they can be taken apart and put back together. Broken slates, worn flashings, rotted sheathing boards, or any element can be removed and replaced without the need to replace the entire roof. Because of this unusual maintenance characteristic, slate roofs can be made to last as long as the slate itself will last, which could be hundreds of years.

When repairing or restoring a slate roof, individual slates are removed to expose the existing flashings, which can then be removed and replaced. The removed slates can then be put back into their original positions, and the repaired roof will look much the same as it did before the repair. Faulty slates are also removed in order to be replaced, and matching slates must be used whenever possible. The tool required for removing slates from a roof is the slate ripper (Figure 7), a sword-like object that slides under the slate to be removed and pulls out the two nails that hold it in place. Rippers do not cut the nails as many

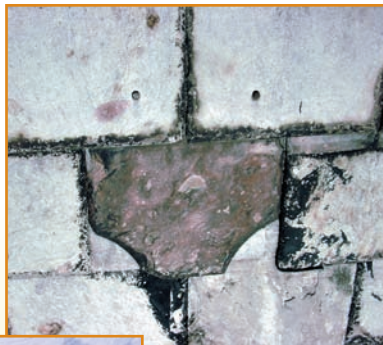
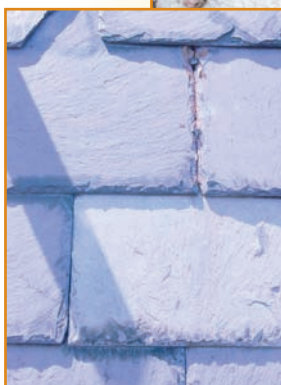
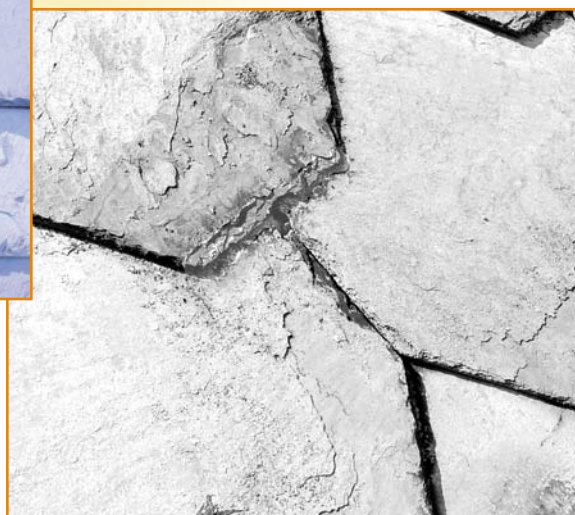
**Photos 10, 11, and 12: Typical bad repairs. 10: wrong type and shape of replacement slate, face-nailed through overlying slates; ugly and a sure leak. 11: Nail in slot to fasten replacement slate, then caulked – another sure leak (should have used a bib flashing). 12: Nail in slot without caulk or bib flashing becomes a “hidden leak” because the hole is almost invisible.**

Finally, one of the most common causes of leaks in older slate roofs is, unfortunately, improper repairs (*Photos 10, 11, and 12*). Bad repairs will still leak, they look ugly, and they can be very costly because the owner usually has to pay to correct them. These combined factors can make a roof owner, in frustration, want to forever remove her slate roof no matter how much longer it will last if properly repaired. In addition, roofing contractors, as well as consultants, who have little or no expertise in slate roofs,

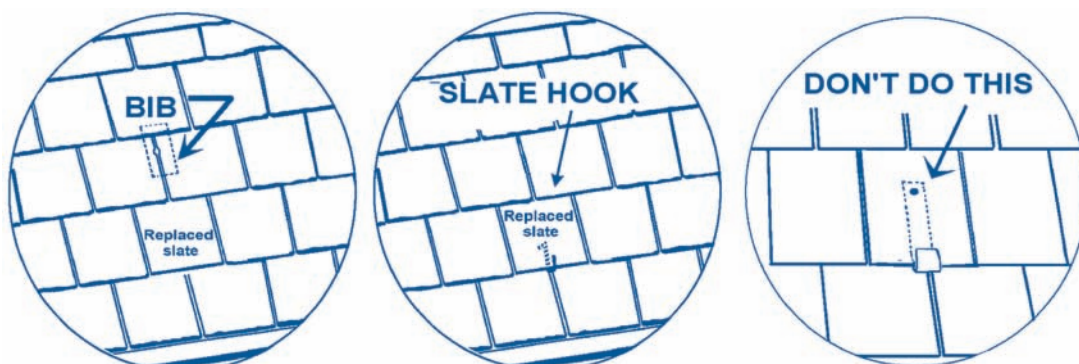
**Figure 13: Standard methods for replacing slates in the field of the roof include the nail-in-slot and bib method (left) and the slate hood method (center). The exposed strap method (right) is to be avoided).**

will advise an owner to replace a slate roof that may have many decades of life remaining. A client will listen to bad advice when it is the only advice that can be found. (See *Figure 13*.)

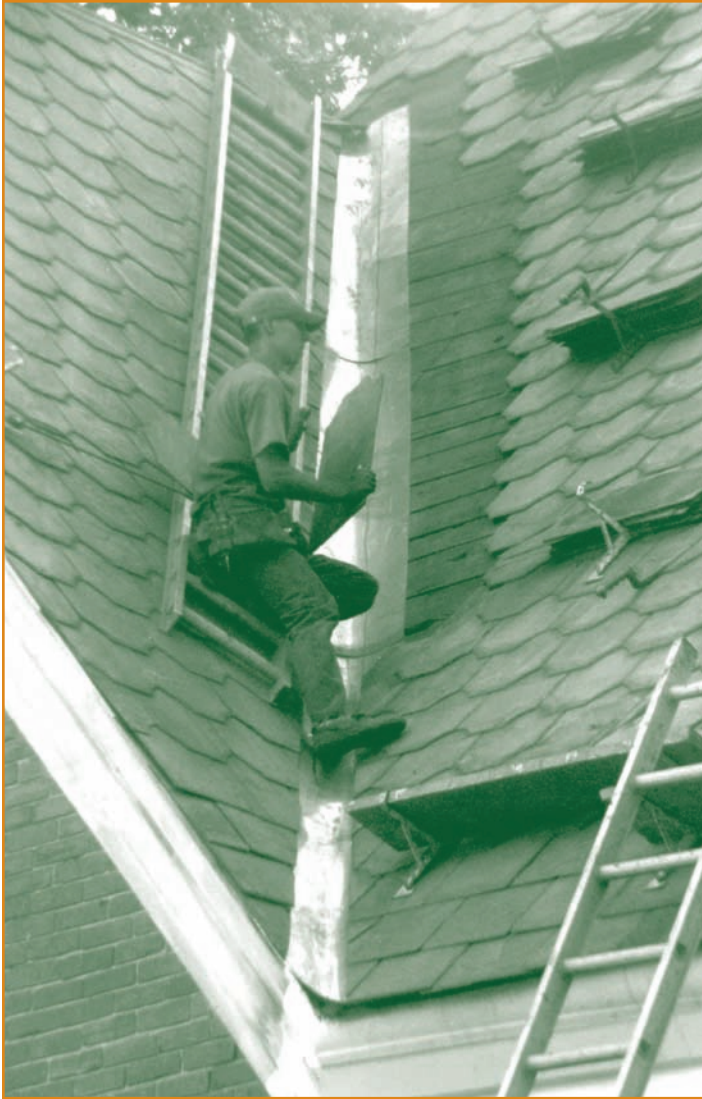
*Photo 14: A fully sheathed board roof deck with a temporary 30-lb. felt underlayment is a very successful tried and proven roofing system used with slate roofs and should be used with all new slate roofs for best results. The felt is optional. No underlayment is needed for the proper functioning of the roof. The valley replacement on a 104-year-old church shown above reveals the 1" hemlock board decking and the complete absence of underlayment. The slate is PA black, still in good condition. No water can penetrate the slate/copper roof system, which is why the underlayment is optional.*

The common steep-slope asphalt roof system of today employs a plywood or other laminated or glued wood product deck, often covered with a self-adhesive underlayment. A properly installed slate roof, however, will avoid any laminated or glued wood product for decking, as these materials have no record of the longevity required for a slate roofing system. Self-adhesive underlayment is a product designed to prolong the life of laminated wood decking, and therefore has no real purpose on a properly constructed slate roof (*Photo 14*).

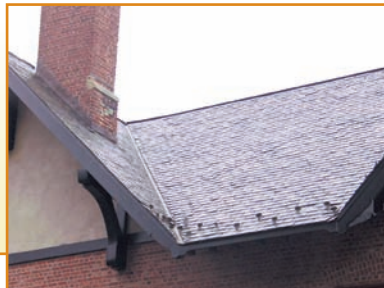
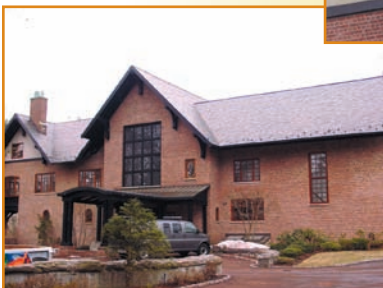
In 2000, an upscale estate in the New York City suburbs was in need of a roof consultation (*Photos 17 and 18*). Some slates had been found on the ground alongside the mansion after the winter ice had thawed, and the owners were concerned. A slate roofing "expert," a "third generation slater," was called in to inspect the roof. He subsequently advised that the entire slate roof needed to be replaced – to the tune of \$450,000. This seemed odd, especially considering that the slate roof in question was only 12 years old! An independent examination by a professional consultant revealed that the snowguards – the metal fixtures on the eaves that hook under the slates and protrude up off the roof surface to prevent snow and ice avalanches – had pulled out under the weight of an excessive snow load. When the snowguards let loose, they pulled some slates off with them, and it all ended up on the ground. The snow guards failed

because there were not enough of them for the size and steepness of the roof. This had been a particularly bad winter for ice and snow, and the sparse snow guards couldn't hold the load.

The entire problem was repairable by replacing the missing slates and doubling the number of snow guards or leaving them off completely. And it was all covered by homeowner's insurance! The lesson to be learned here is that just because someone calls himself an "expert" on slate, that doesn't mean he is. Always get a second opinion in a situation of this magnitude. In this case, it saved the prudent owners nearly half a million dollars!
